Landslides and liquefaction triggered by the M 7.9 Denali Fault earthquake of 3 November 2002

Edwin L. Harp and **Randall W. Jibson**, U.S. Geological Survey, 1711 Illinois Street, Golden, Colorado 80401, USA

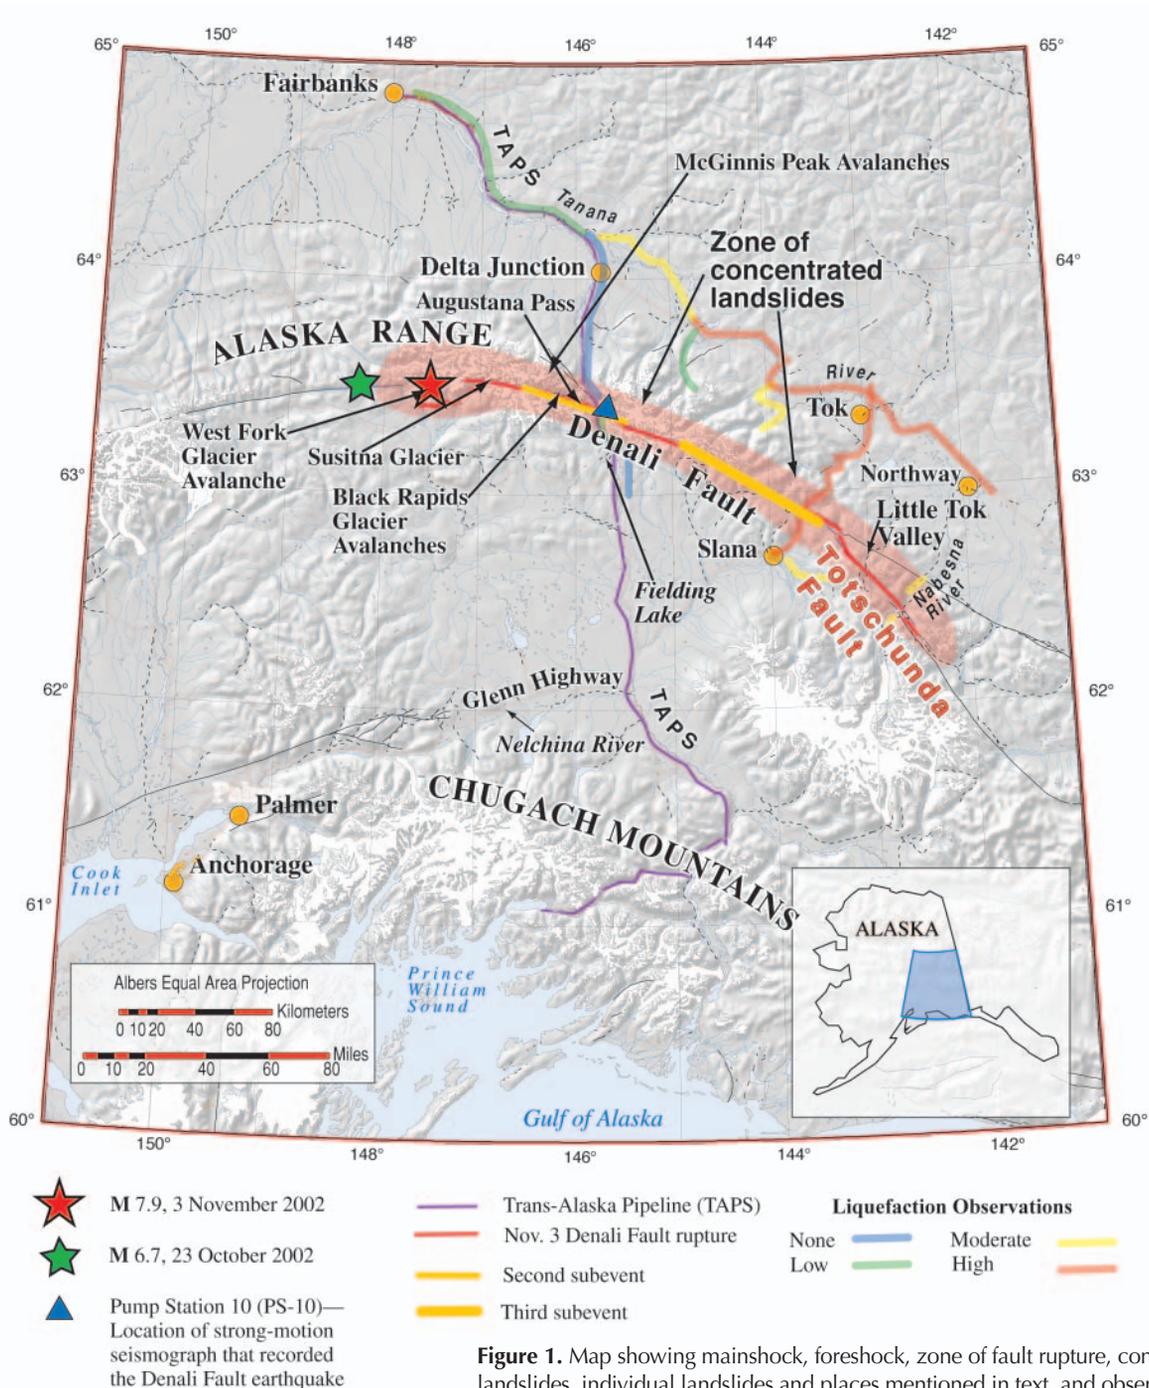
Figure 1. Map showing mainshock, foreshock, zone of fault rupture, concentrated landslides, individual landslides and places mentioned in text, and observations of liquefaction effects triggered by the Denali Fault earthquake of 3 November 2002.

2002). In this earthquake, the majority of landslides clustered in a narrow band ~30 km wide that straddles the fault for more than 300 km (Fig. 1). Only a few rock falls were found at greater distances from the fault, despite the fact that highly susceptible, steep slopes of intensely fractured rock are abundantly present beyond the observed 15 km limit on each side of the fault. The most distant triggered landslides we observed were a few scattered rock falls in the Chugach Mountains near

Liquefaction effects increased notably in severity and spatial extent toward the east end of the rupture zone (Fig. 1). On the north side of the Alaska Range in the Tanana River valley (Fig. 1), at 50–120 km from the zone of fault rupture, we saw extensive evidence of liquefaction where fluvial deposits of sand and silt were capped by a thin (<0.3 m) frozen surface layer. Liquefaction within the Tanana River valley was widespread from Fairbanks on the west to at least several hundred kilometers eastward. Liquefaction damage became increasingly severe to the east of Delta Junction, even as distance from the fault increased. In the Tok area, nearly every river bar contained extensive liquefaction effects. Farther east, for many kilometers around the towns of Northway and Slana, large continuous lowland areas of liquefaction and lateral-spread failures were observed. Two measured transects along the Tanana River at Tetlin Bridge, west of Tok, showed 3%–4% of lateral spreading of sand bars across

Concentrations and severity of liquefaction effects were especially high over a large region near the eastern end of the ruptured Denali Fault and the Totschunda Fault, where the fault displacement was greatest (Fig. 1).

Keefer's (2002) relationship between areas affected by landslides and earthquake magnitude shows that the mean area affected by a M 7.9 earthquake is ~28,000 km². Based on the landslide distribution shown in Figure 1, the area affected by the November 3 earthquake measures only 10,000 km². In contrast, the area affected by landslides triggered by the 1964 Alaska earthquake of M 9.2 was ~200,000 km², and the farthest landslides were triggered 700 km from the epicenter (Keefer, 1984, 2002).

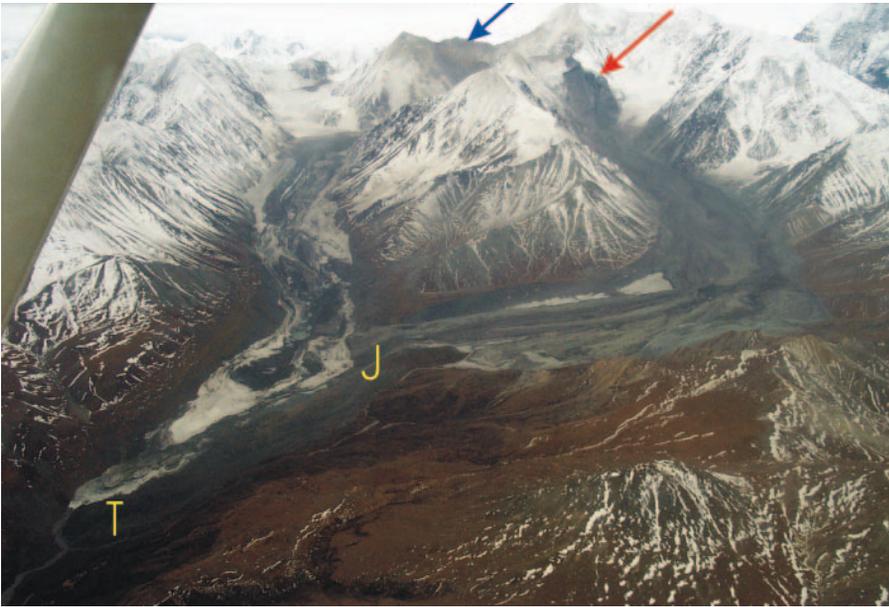
Figure 2. McGinnis Peak landslides. Two huge rock avalanches originated from different flanks of McGinnis Peak. The avalanche to the right (red arrow denoting head scarp) is composed mainly of rock and is ~40 million m³ in volume. The runout path of this avalanche is ~10 km. The avalanche to the left (blue arrow denoting head scarp) has more ice and snow included within the avalanche debris. The landslides converged in the lower left part of the photo (J), and the avalanche on the left continued down to the toe of McGinnis Glacier (T).

rock avalanche eventually butted up against another similar rock and ice avalanche that was triggered from the southern ridge of the peak. The toe of this avalanche traveled another kilometer past this junction almost to the toe of McGinnis Glacier. This avalanche contained significantly more ice and snow, perhaps as much as 30% of the volume of the deposit.

When we compared the runout distance of the McGinnis Peak rock avalanche with those of other avalanches worldwide, using data from Shaller (1991) and Evans and Clague (1988), we find that the McGinnis Peak rock avalanche plots within the data cluster of landslides similar in volume, indicating that its runout distance is not exceptional despite the entire runout path being on ice.

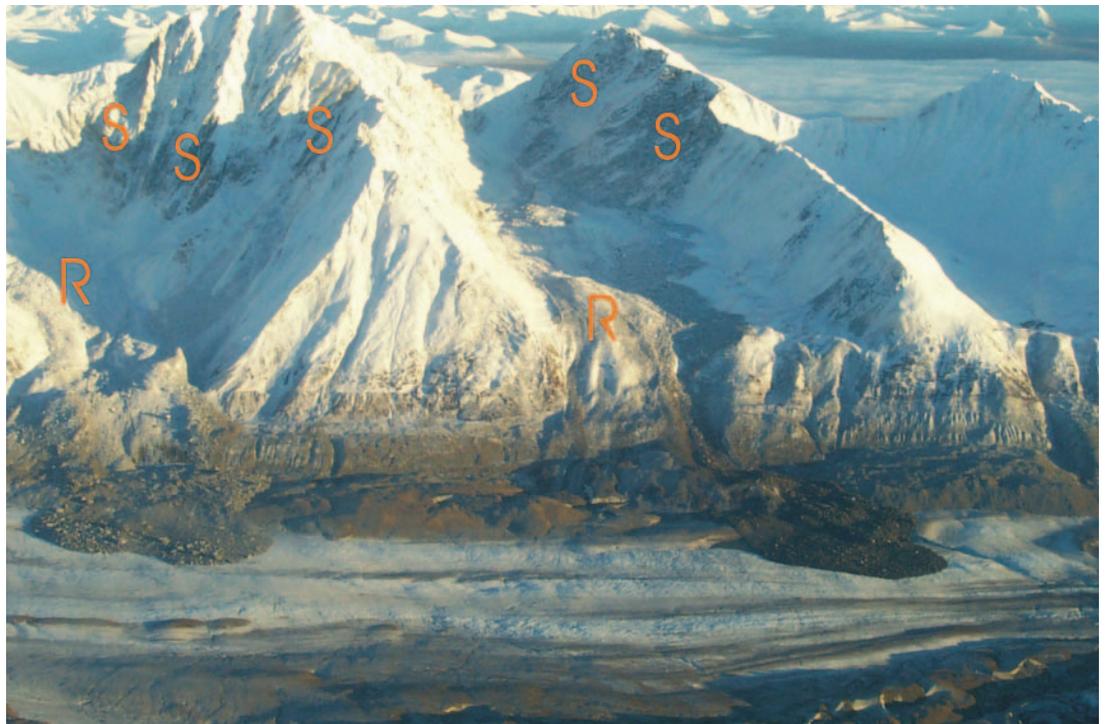
Figure 3. Rock avalanches deposited on the surface of the West Fork Glacier near the earthquake epicenter. “S” indicates source areas within the cirques where recent snow obscures their features. “R” indicates runout paths of the avalanche deposits.

Two large rock avalanches were triggered above the West Fork Glacier (Fig. 3) from near-vertical slopes in two glacial cirques, shown in Figure 3. As the dislodged rock moved rapidly down the cirques, debris from the avalanche to the left in Figure 3 became airborne for a short distance as it traveled over the lateral moraine at the edge of the valley and spread out as it fell onto the glacial surface. Parts of the lee side of this lateral moraine were undisturbed by the avalanche, indicating that at least some of the avalanche debris must have been airborne to avoid impact with this part of the moraine. The deposit of this avalanche mainly consisted of large blocks of metamorphic rock (possibly as much as 70% by volume); some individual blocks were more than 20 m on a side (Fig. 4). Thicknesses of the deposits ranged between 3 and 15 m.

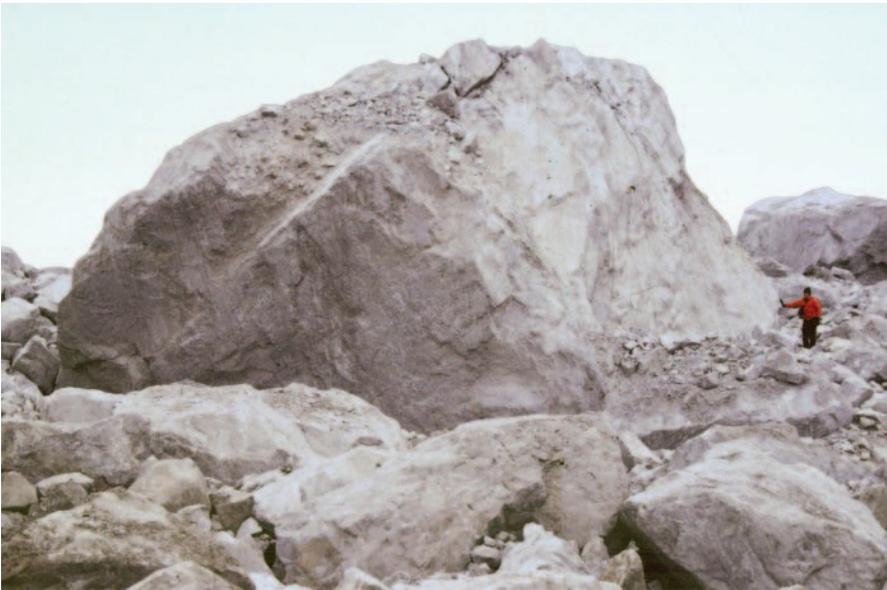
Figure 4. Deposit of one of the West Fork Glacier avalanches consisting primarily of huge blocks. The block shown (with a person for scale) is ~20 m in longest dimension.

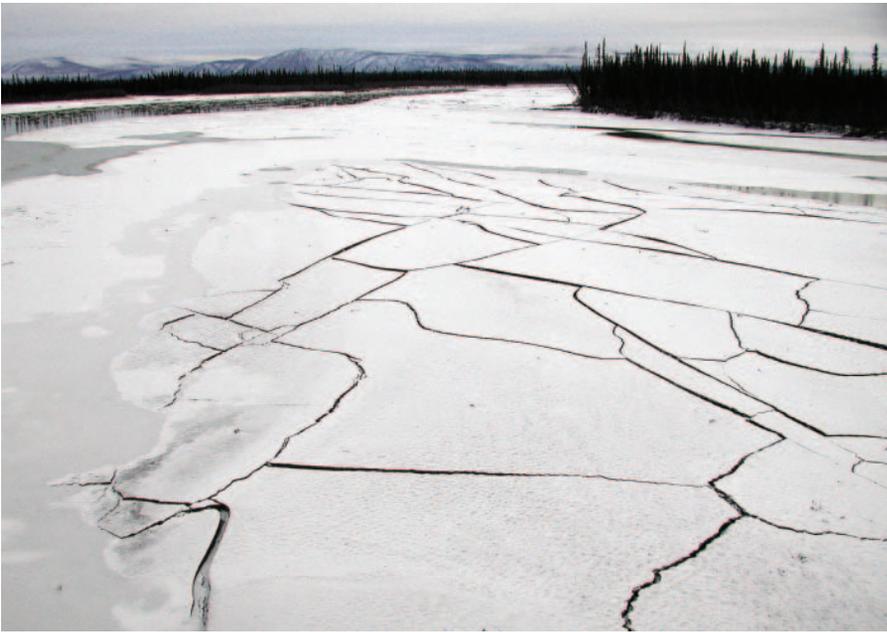
Figure 5. Polygonal cracks in frozen surface of floodplain deposits of Tanana River. For several hundred kilometers along the Tanana River (here near the town of Tetlin Junction), a pattern of polygonal surface fractures defined liquefaction-induced laterally deforming ground. The polygons formed when the frozen crust (≤ 0.3 m thick) above liquefied ground fractured and displaced.

where the ground spread laterally toward the river. More commonly, the frozen ground surface displayed randomly oriented sublinear fissures, which formed polygon networks that could be traced for several kilometers (Fig. 5).

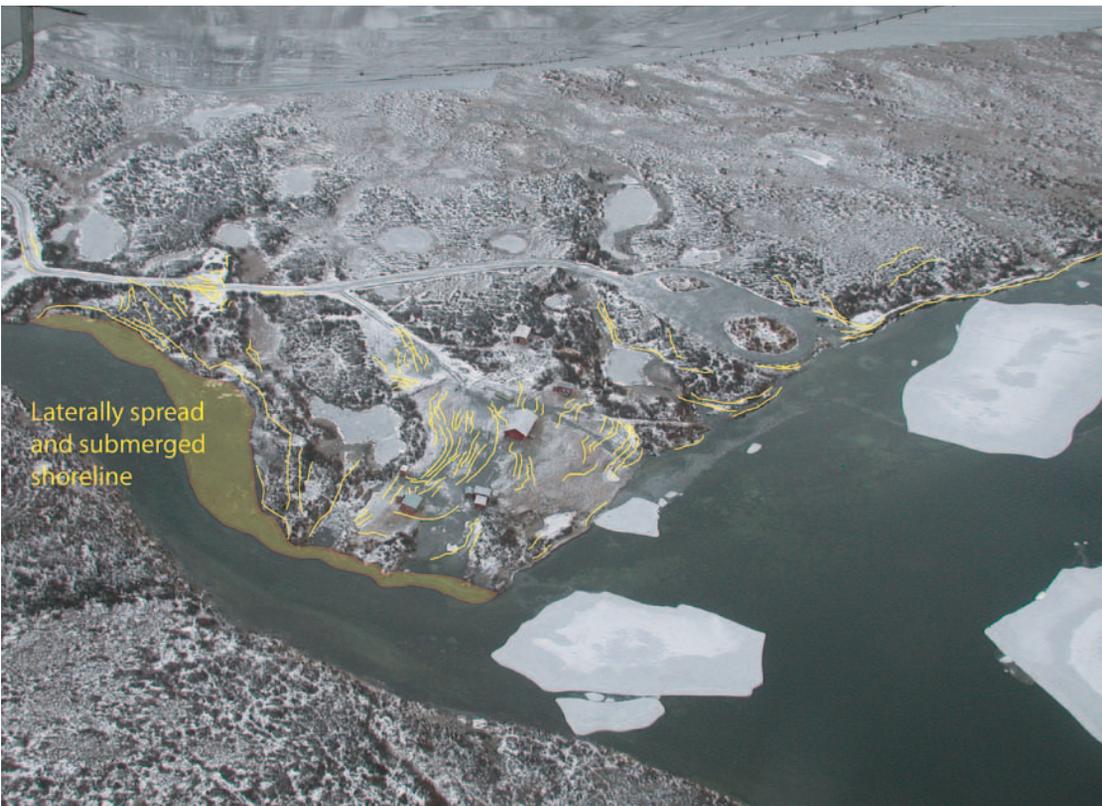
Figure 6. Lateral spreads and sand vents above liquefied ground at Fielding Lake Park was observed from the air and later mapped. The pattern of fissures (yellow lines) are generally across slope as ground slid toward low land areas and the lakeshore.

Widespread liquefaction, lateral spreading, sand boils, and submerged ground were observed at Fielding Lake, where the upper soil crust was not frozen at the time of the earthquake (Fig. 6). Structures on the spreading ground were deformed and displaced, including an underground septic tank that was buoyed to the surface, lifting an outhouse.
