Katrina's unique splay deposits in a New Orleans neighborhood

Stephen A. Nelson* and Suzanne F. Leclair*, Department of Earth and Environmental Sciences, Tulane University, New Orleans, Louisiana 70118, USA

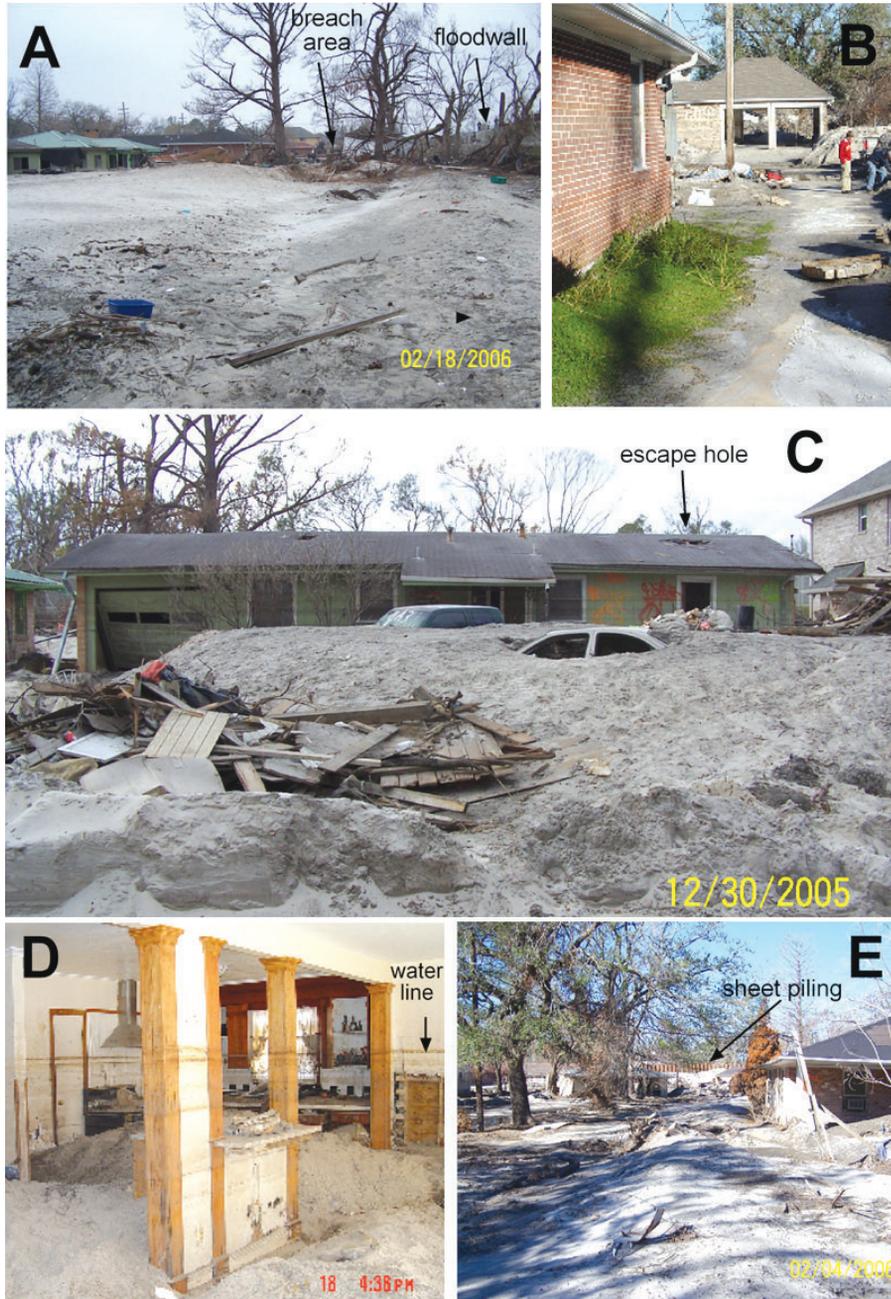
Figure 5. Photographs of sandy splay deposits. Refer to Figure 4 for locations. (A) View from backyard of house no. 5, looking south toward the breach; there are two ridges of sand, parallel to flow direction, with a maximum thickness of 1.8 m. (B) Driveway between houses no. 2 and no. 3, with absence of sand along the red brick house, and the open garage across the street where the flow ran through it. (C) Roofs of cars protruding through the sand deposit in front of house no. 5. Note the holes in the house's roof that were used as exits for residents escaping the floodwaters. (D) Sand deposits in the kitchen of house no. 2. Note the water lines on the walls that resulted from three weeks of standing water. (E) View from Wilton Drive, looking west toward the levee breach; sand deposits on the right; displaced house shown below the trees in the middle distance; and brown temporary sheet piling levee repair in the far distance.

In plan view, the splay deposit shows elongate lobes spreading up to ~400 m from the breach (Fig. 4). This plan shape is clearly different from that of natural splay deposits (e.g., Smith et al., 1989; Gomez et al., 1997), because it was influenced by the street pattern and urban structures. Immediately north of the breach, the flow deposited up to 1.8 m of sand in the backyards and in front of the houses on Warrington Drive (Fig. 4). Along the backyards of these houses, the sand surface shows two ridges parallel to each other and to the canal (Fig. 5A). No sediment was deposited along some driveways between houses (Figs. 4 and 5B), but sand

buried vehicles in the front yards (Fig. 5C) and was deposited within houses near the breach (Fig. 5D). Sand was also deposited along the streets intersecting Warrington Drive, with thicknesses up to 1 m (Figs. 4 and 5E). The most distal parts of the splay were <0.3 m thick, and hence the gradient of the deposit's upper surface is nearly 0.004.
